1345 Sample St., Faketown, FL 32803  
Inspection prepared for: For Instance  
Date of Inspection: 1/9/2016 Time: 10:00 AM  
Age of Home: 1954  
Order ID: 145

Inspector: Travis McFarran  
License #8229  
1026 Tompkins Dr., Port Orange, FL 32129  
Phone: (386) 589-2338  
Email: [truemeasureinspections@gmail.com](mailto:truemeasureinspections@gmail.com)  
[www.truemeasurehomeinspections.com](http://www.truemeasurehomeinspections.com)

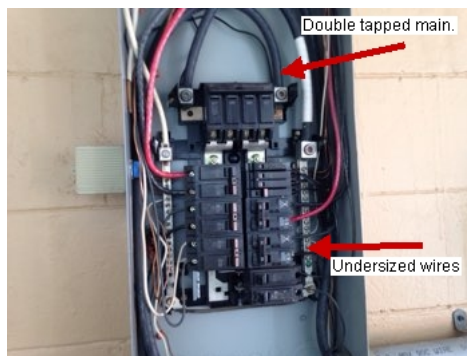
- The main hot lugs have more than one wire connected to them. This is a safety hazard as that circuit is not protected by any circuit breakers. This needs to be repaired.

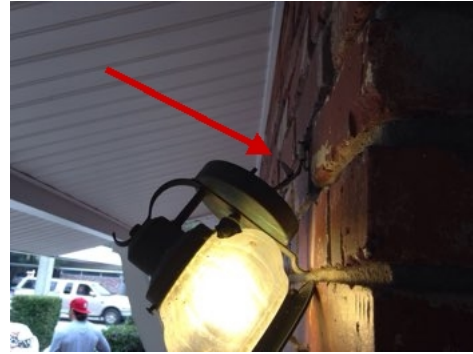
- The wiring is a combination of the original cloth covered wiring and the newer plastic coated wiring. The cloth covered wiring is older and covered by insulation, so much of it could not be seen. The cloth covering will continue to wear out and have to be replaced at some time in the future when it can no longer serve its purpose of insulating the wires. Also, rodents can chew through this wiring and allow it to become exposed to the insulation, which makes this a safety hazard. Some insurance companies may not insure the house due to this wiring being installed.
- There are exposed electrical wires.

Exposed wires.

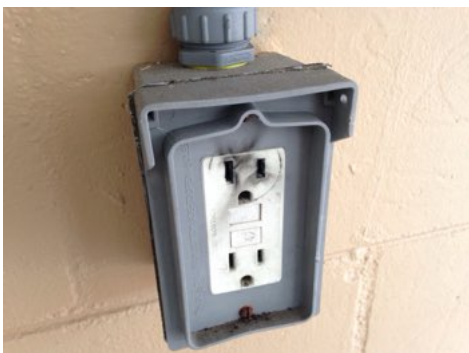
- There are no GFCI outlets in areas that require them, such as the exterior, bathrooms or any area exposed to a water source.
- There are electrical outlets that have scorch marks on the outside of them. This indicates past arcing/shorts in the electrical circuit. This needs to be further evaluated and repaired by a licensed electrician.

This was seen on the back patio, and garage.

Scorched outlet

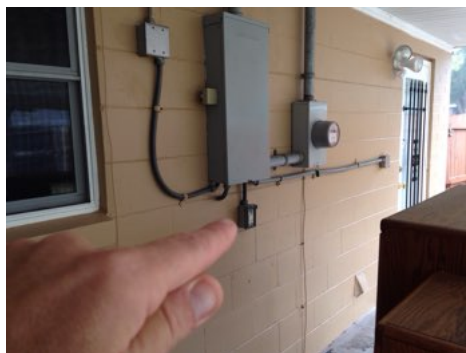
Scorced outlet is here.

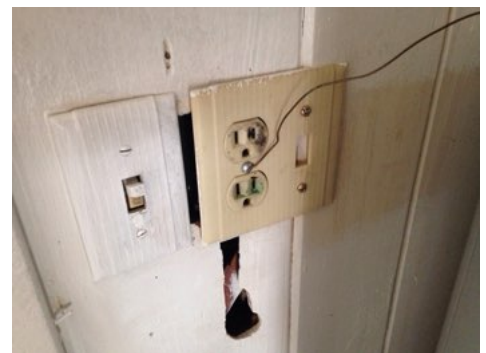
Scorched outlet near water heater

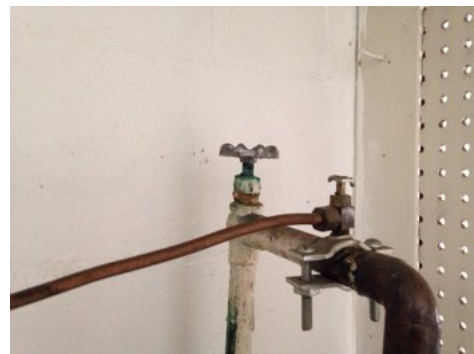
- There is a saddle valve installed. This is a valve that connects to a copper pipe by puncturing the pipe to allow water to flow out into the valve. These have a tendency to cause leaks and is an unprofessional installation. I recommend removing this valve and having a proper valve installed in its place.
- There were areas of water supply piping that were stained and possibly leaking. These are at the crawlspace under the master shower. There is a significant leak at that shower, and it is hard to tell if the supply lines themselves are leaking. I recommend having these pipes evaluated while having the leaking shower/drain line estimated for repair.

Saddle valve at water heater

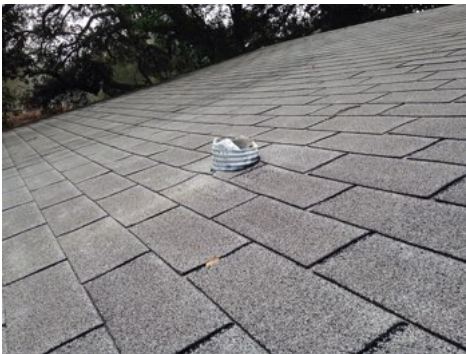
- There are vent pipes on the roof that do not extend far enough above the roof line. These should be 2-3 feet above the roof to allow the gasses to flow freely from the pipes.
- There is a cast iron pipe that appears to be leaking under the master bathroom. This pipe may need to be replaced. There was a significant leak seen in the shower of this bathroom, there may be more problems discovered with this cast iron piping while work is being performed.

Vent pipes should extend 2-3 feet above the roof line.

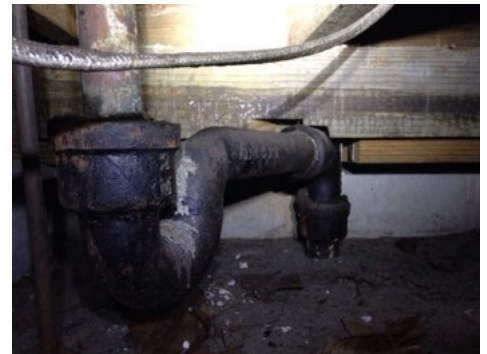
- The piping that takes the waste water from the fixtures to the main waste piping is a mixture of different materials.
  - The piping that takes the waste water to the sewer system is made of cast iron where visible. There was significant rust seen on portions of the drain pipe. This pipe may need replacement for this reason and insurance purposes. I recommend getting several estimates from qualified plumbing contractors before the end of your inspection contingency period for replacement.
-

Cast iron waste line at master bath toilet and sink.

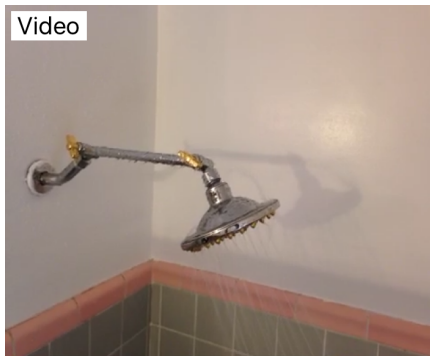
- The shower faucet leaks when in use in the hall bathroom.
- There are areas of cracked tile in the shower floor in the hall bathroom. There was a significant leak seen under the shower in the crawlspace. This indicates that the shower pan is damaged and leaking. The shower floor needs to be repaired along with the pan underneath. There may be more damage when the floor is opened, so it is best to get an estimate from a qualified plumber prior to the end of your inspection contingency period.

Shower head leaks when in use.

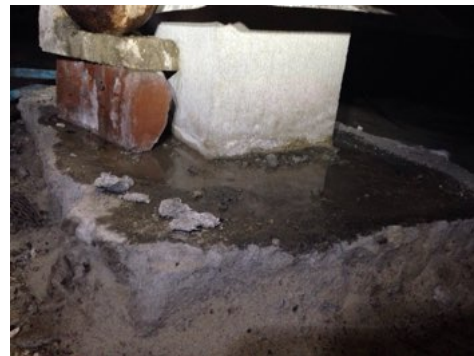
Leak under shower in master bath

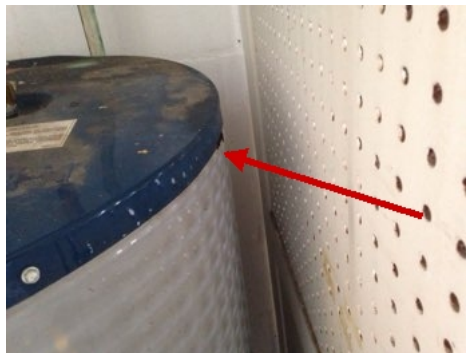
- There are rusted areas on the pipes of the water heater. This indicates a past leak. While there was no leak found during the inspection, I recommend close monitoring of the unit for future leaks.
- The water heater enclosure is rusted in areas. This can be a potential for a leak.
- The water heater is older, and seemed to take more time than usual to heat the water in the house.

Rusty enclosure.

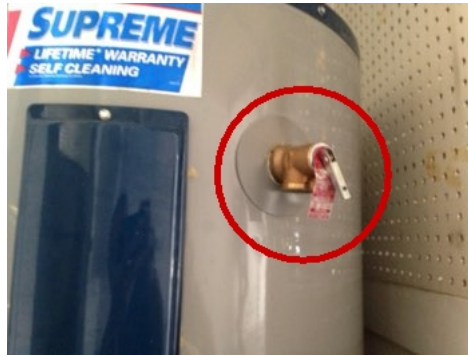
- The temperature/pressure relief valve has a partial drain line installed but it does not go far enough to take the water away to a safe location. We recommend this drainline be properly installed in case this valve ever releases hot water.

No extension on TPR valve.

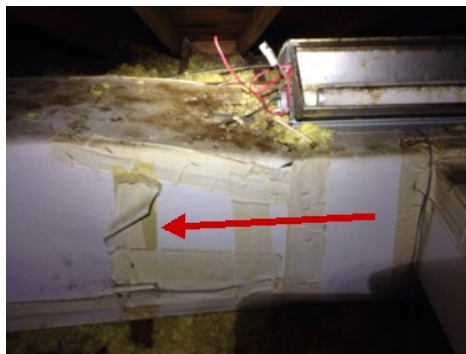
- There are damaged areas of duct tape, that is letting air escape.

Air escaping here. This is near the attic access in the hall.

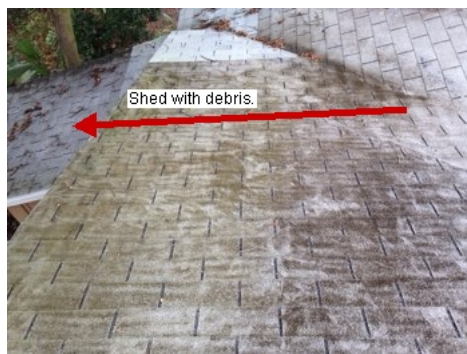
- Based on the age of the house, the style of shingle used, and the condition of this roof, I estimate this roof is about 18-20 years old. The typical life expectancy for a roof of this style and material is around 20 years depending on weather, location, environmental hazards like trees in close proximity, and many other factors.
- There are areas of moss/mildew on the roof. This needs to be cleaned to prevent premature failure of the shingles.
- There are areas of active leaks in the roof that were seen from inside the shed. These appear to be caused by debris buildup on the south side of the roof. This debris should be cleared off to determine if it is in fact the cause of the leak, and then any needed repairs made.

Mildew should be cleaned. Shed is on the left with the debris causing leaks.

It is important to keep this area clear of debris in the future.

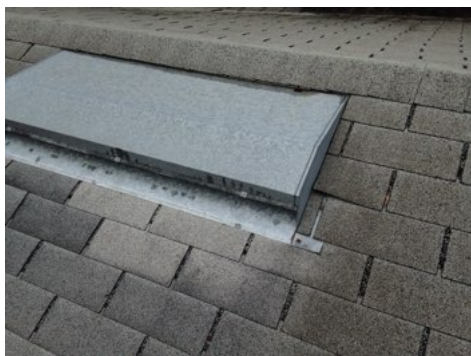
- There are flashings that have been covered over with roofing compound/cement which is a temporary solution and will require regular maintenance to help ensure a leak free condition. This was seen at the chimney, and there was moisture staining in the attic near the chimney. This indicates that there has been leaks at this flashing in the past. Monitor this area for future leaking, and when the time for a roof replacement comes, suggest that the roofing company make a more permanent repair.
- There are penetrations through the flashing that are going to require high maintenance and should be closely monitored to prevent leaks.

Exposed nails

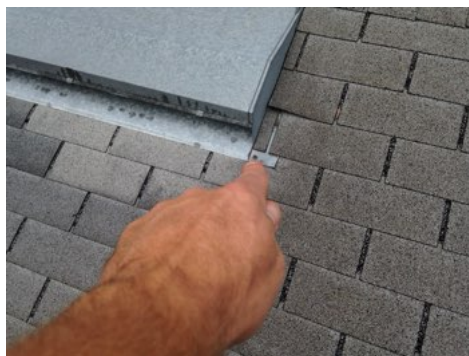
Exposed nails

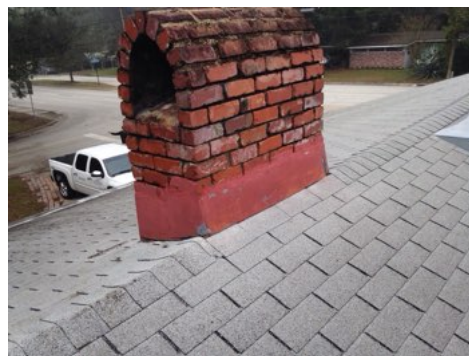
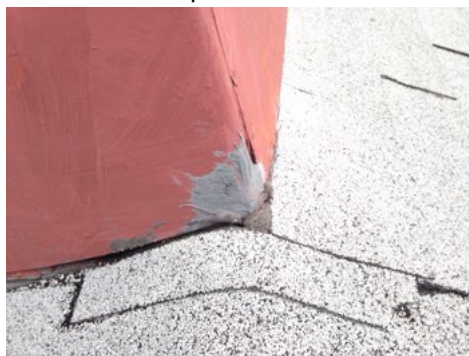
Covered flashing

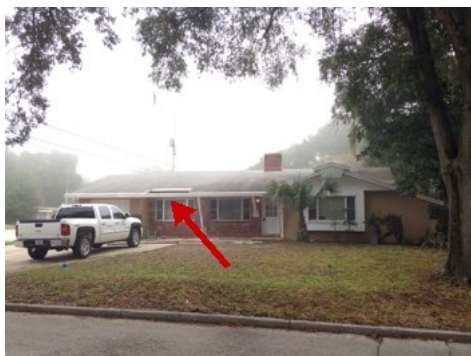
• There is a portion of the roof that is notched from the rest of the roof. This is in the front of the house. The gutter spans the notch in an unconventional manner. This gutter is attached to a piece of wood that spans the notch as well. This wood is wrapped in an aluminum material, and the seam of the aluminum material is open at the top allowing water to penetrate the wood.

Notched area is here

I would recommend removing the gutter from this area and installing new gutter at the back of the notch.

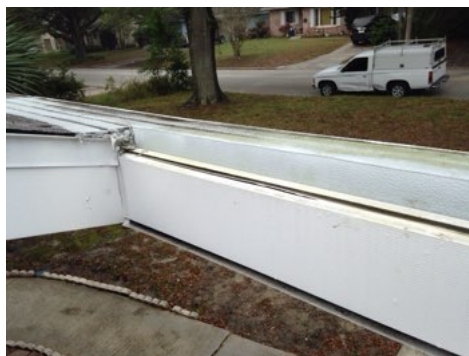
Exposed wood in here. Getting wet.

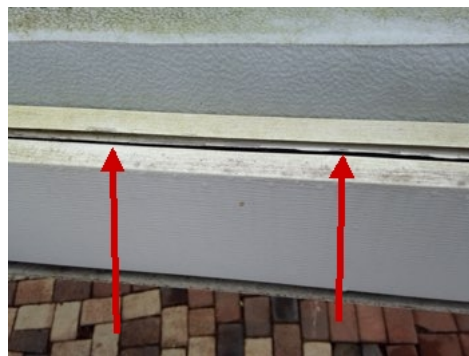
Gap in aluminum material.

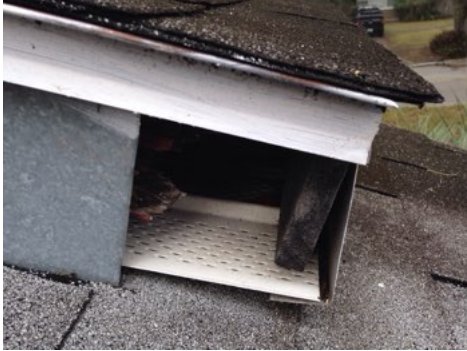
- The fascia is enclosed with aluminum.
- The soffit and fascia were in good shape at the time of the inspection.
- The fascia is missing on the backside of the dormer over the master bedroom. This has allowed the wood inside to become moisture damaged. This should be repaired to keep pests and moisture out.

Missing fascia at dormer.

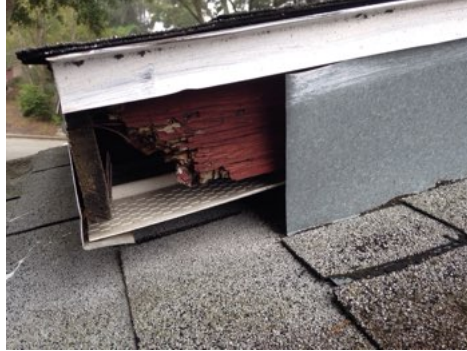
Missing fascia at dormer.

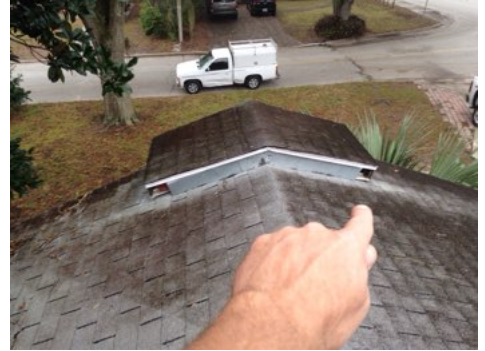
Missing fascia at dormer.

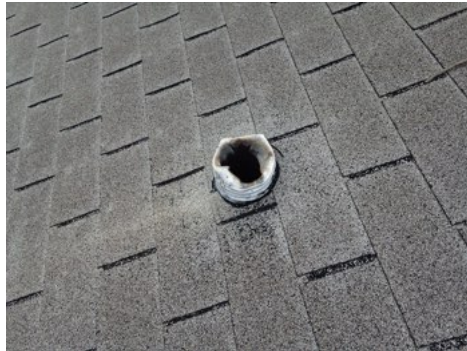
Vent pipes should extend 2-3 feet above the roof line.

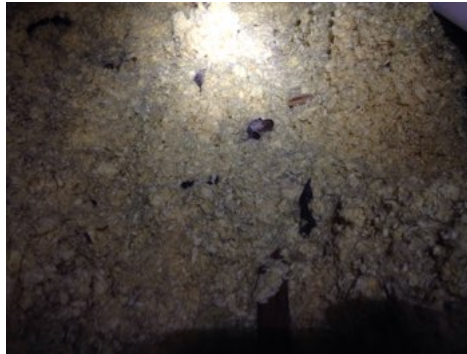
Feces

- There was fecal matter found in the attic from what appears to be rodents and cats. These animals were not seen in the attic.

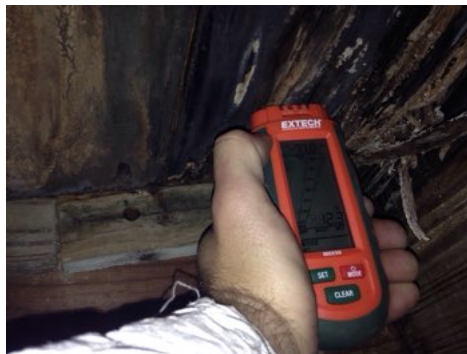
- There are areas of floor framing that are stained from leaks in plumbing. This was seen at and the master bathroom. These areas tested dry with a moisture meter at the time of the inspection.
- There are areas of floor framing that are damaged from leaks in plumbing. This was seen at at the outside of the tub on the drain side. These areas tested dry with a moisture meter at the time of the inspection.
- There are areas of floor framing that are damaged from leaks in plumbing. This was seen at . These areas were currently wet and leaking. See plumbing section for further information.

Moisture damage near tub in hall bath. Tested dry.

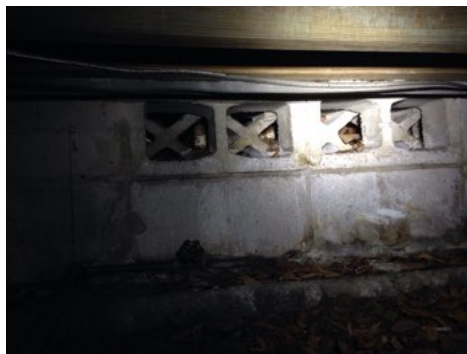
- There are fresh air vents that are blocked which reduces the air flow to the crawl space. This can lead to ventilation problems under the structure and they should be unblocked.
- Some foundation vents have no screens over them. This can allow animals to enter the crawlspace. Replace screens to keep pests out.

Missing screens in the front. Also these are blocked.

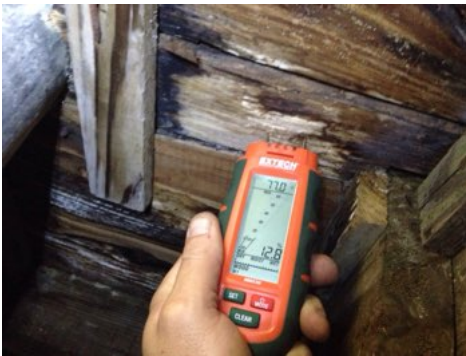
Moisture staining near toilet in hall bath. Tested dry.

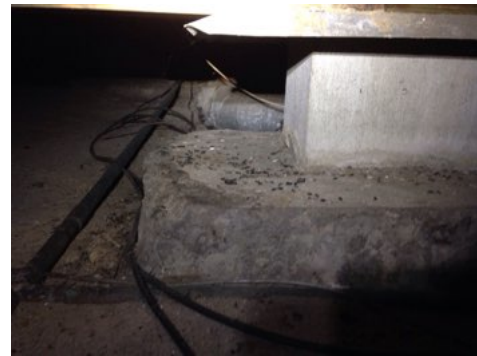
- The crawl space under the building has areas that could not be accessed. These areas were blocked off and could not be entered
- Rodent droppings were observed in the crawl space. It is advised to have a specialist in this area examine the structure and property to determine the presence or not of any infestation and recommend any corrective measures.

Rodent feces in crawl space.

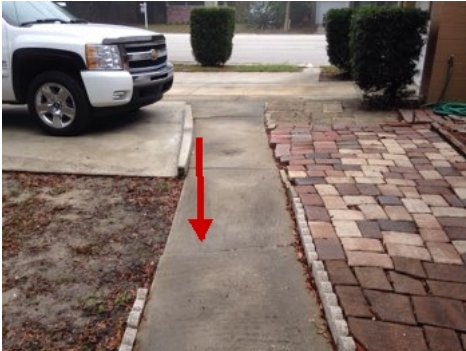
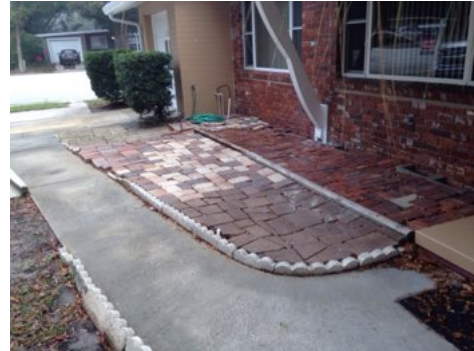
- There are trip hazards in the walkways.
- There are cracked areas of the walkways that are typical for the age and style of construction.

There are trip hazards in the walkways.

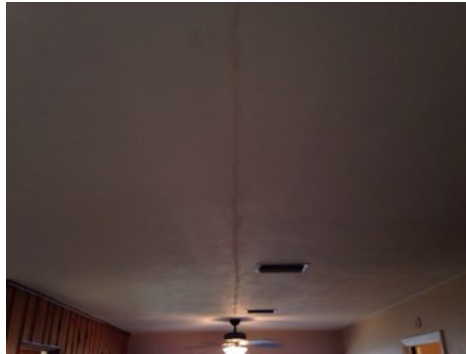
- There are areas of stress cracks in the walls and ceilings that are typical for this age house and type of construction.

Ceiling crack in dining room.

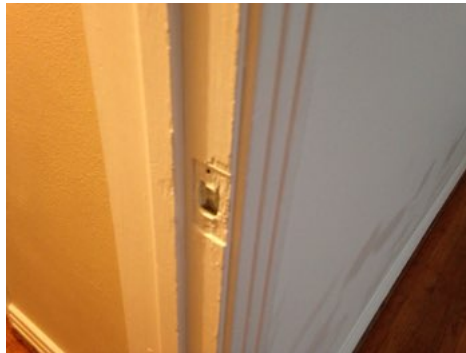
- The cabinets in the house were inspected and were in good condition at the time of the inspection.
- The door in the hall bedroom doesn't stay closed due to a missing strike plate.

Missing strike plate in hall bath.
