123 Main Street, Anytown, FL 32129
Inspection prepared for: Sample Client
Date of Inspection: 1/21/2016 Time: 10:00 AM
Age of Home: 1986 Size: 1761
Order ID: 146

Inspector: Travis McFarran
License #8229
1026 Tompkins Dr., Port Orange, FL 32129
Phone: (386) 589-2338
Email: truemeasureinspections@gmail.com
www.truemeasurehomeinspections.com

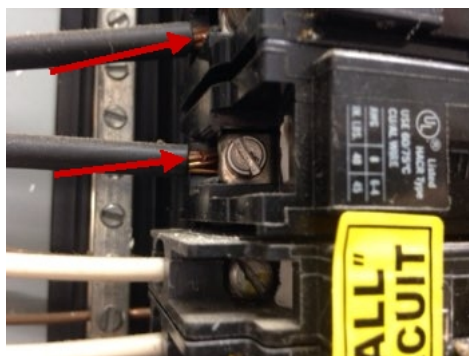
Item number 1

- 5.1. There are wires that have been knicked inside the main electrical panel. This should be repaired by a licensed electrician.

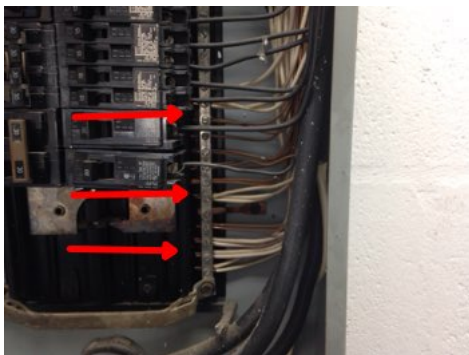
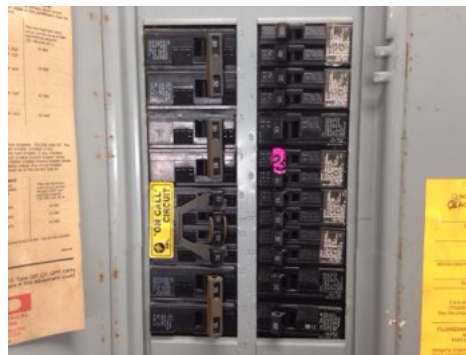
Item number 1 & 2

- 7.1. There are lugs on the grounding buss bar that have too many wires connected to them.

- 7.2. There are lugs on the neutral buss bar that have too many wires connected to them.

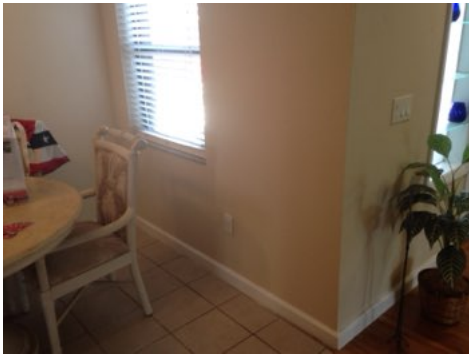
Item number 1

8.1. There are outlets that loose in various areas.

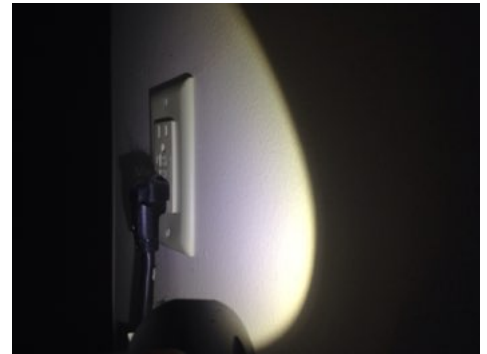
Item number 3

8.3. There are outlets that had the wires reversed in them (this is called reversed polarity). These outlets are still live and will work but could potentially cause a shock hazard. I recommend a licensed electrician repair for safety reasons.

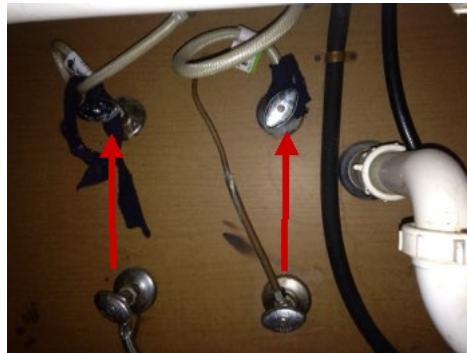
Item number 1

- 4.1. There were leaks seen in the water supply piping. These are at the kitchen sink.

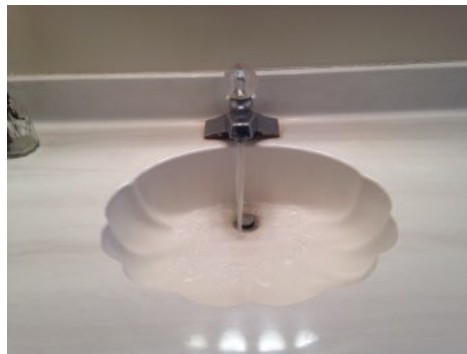
Item number 1

- 5.1. The sink stoppers do not work properly in the master bathroom sink.

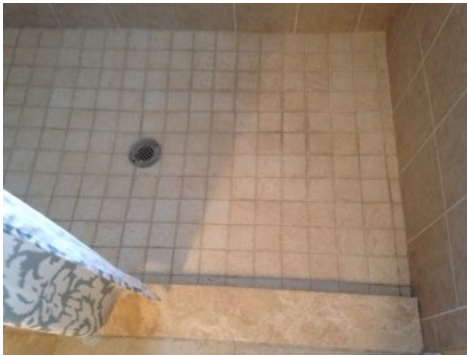
Item number 1

7.1. There is an open shower stall in the master bathroom, there is a possibility of water splashing out of the stall while running the shower.

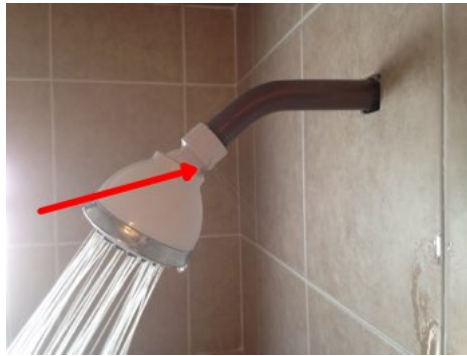
Item number 2

7.2. The shower faucet leaks when in use in the master bathroom.

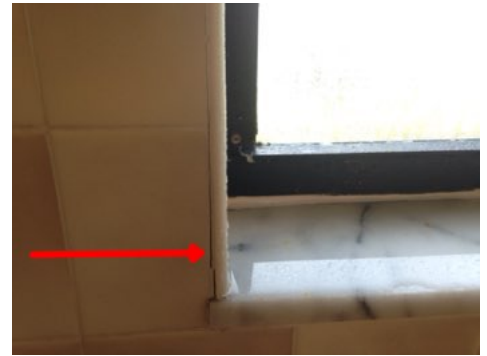
Item number 3

7.3. There are areas of the shower that should be re caulked / grouted to prevent water from penetrating the walls in the hall bathroom.

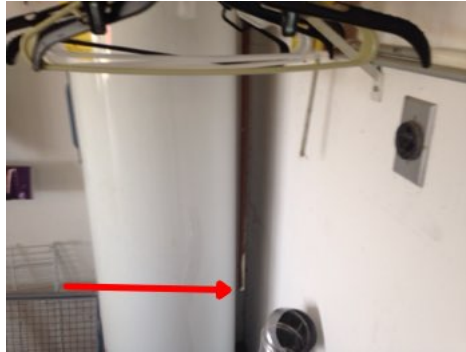
Item number 1

12.1. The temperature/pressure relief valve has a partial drain line installed but it does not go far enough to take the water away to a safe location. We recommend this drainline be properly installed in case this valve ever releases hot water.

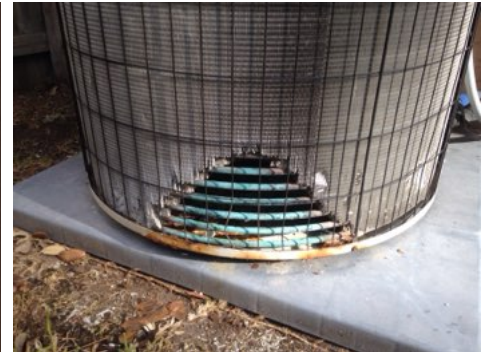
Item number 1

- 2.1. There is damage to the fins on the outside condensing unit.

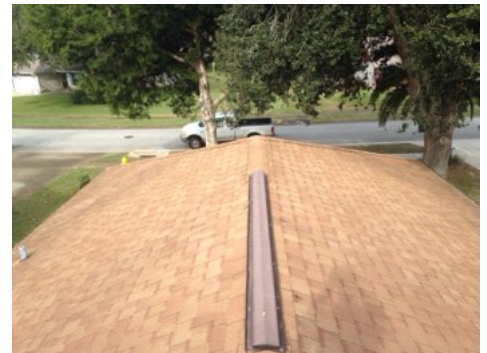
Item number 2

3.2. There are areas of moss/mildew on the roof. This needs to be cleaned to prevent premature failure of the shingles.

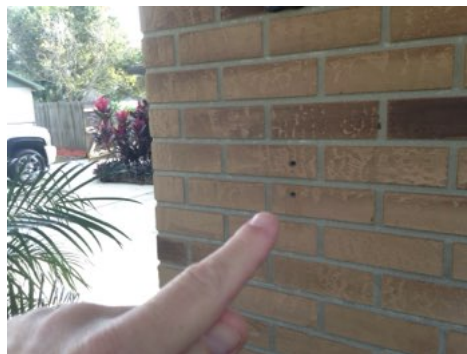
Item number 1

2.1. There are gaps or openings in the siding that need to be corrected to keep out pests and moisture.

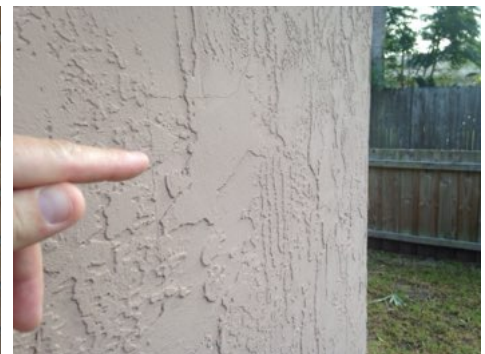
Item number 2

2.2. There is typical cracking in the exterior stucco. These should be sealed to prevent moisture and pests from invading the structure.

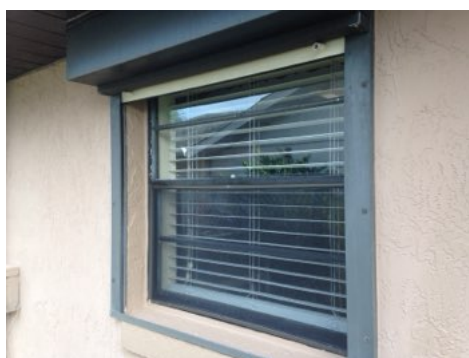
Item number 1

6.1. The windows in this house are older and inefficient. Replacing with newer style will enhance the efficiency and soundproofing of the house.

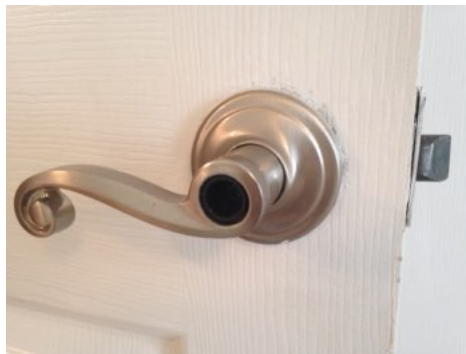
2.1. There are doors that are missing parts of the handle. These are in bedroom 2.

Item number 1 - Bedroom 2

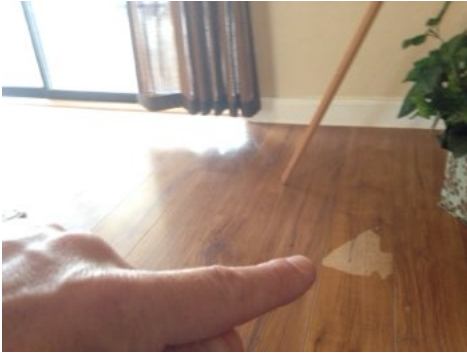
Item number 1

3.1. The laminate flooring is damaged in areas in the living room.

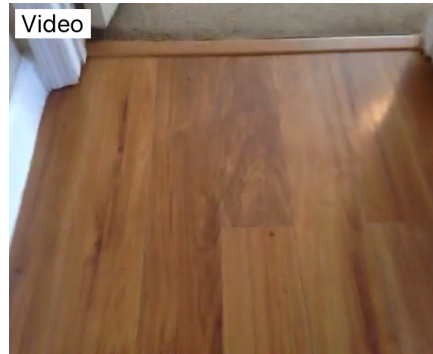
3.2. There are laminate flooring planks that are loose and slip out of place in the hallway.

Item number 2 - Loose flooring

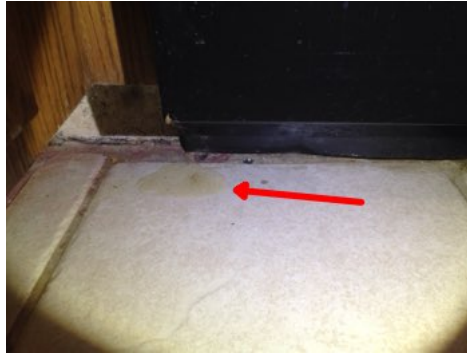
- 3.1. There was evidence that the dishwasher has leaked. There was moisture damage near the unit. No water was seen at this location during the inspection.

- 3.2. The dishwasher was ran and it appears to have a small leak. The source of this leak was unable to be determined.

Leak near dishwasher
